**SAS Superstructure**

Location: 04-SF-80-13.2 / 13.9

Daily Diary Report by Bid Item

Diary #: 704 Const Calendar Day: 147 Date: 29-Oct-2012 Monday

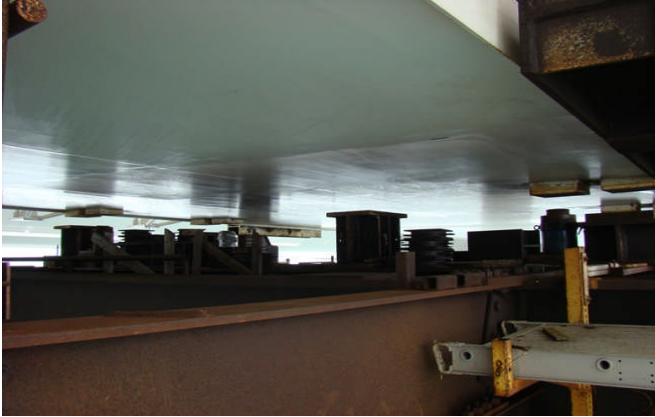
Shims removed at the E-Line Skyway steel tub falsework for vertical movement due to thermal expansion of the SAS and Skyway.

- Checked the progress of the Hinge A pipe beam installation/adjustment operations. ABF ironworkers were seen today removing the shims on the Skyway falsework and mobilizing equipment inside of the W-Line SAS and Skyway bridges. Removing the shims from the Skyway falsework will enable the SAS/Skyway bridges to move freely without bearing on these shims due to the vertical movement induced by thermal expansion. See photos below for more details and comments, also see Parviz Jalali's diary for more details on today's work by ABF ironworkers, labor, and equipment.

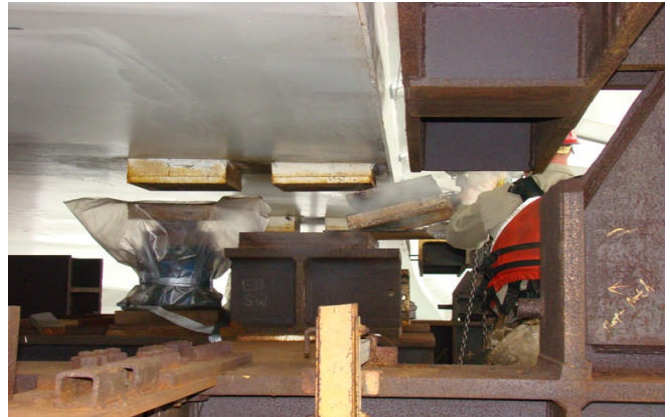
ABF ironworkers removing support shims on the E-Line Skyway steel tub falsework.

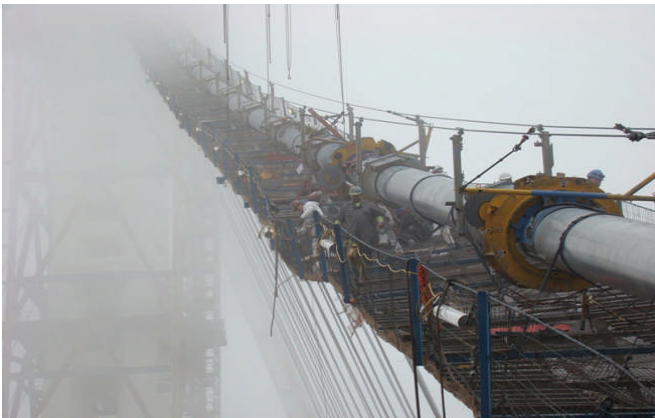
Cable wrapping operation on the South Sidespan looking east towards the tower.

- Completed outstanding diaries and inspection checklist from last week for cable wrapping.

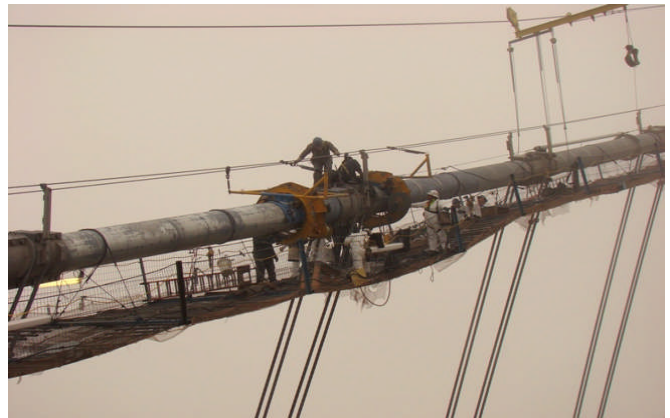
Cable wrapping operation on the North Sidespan looking north.

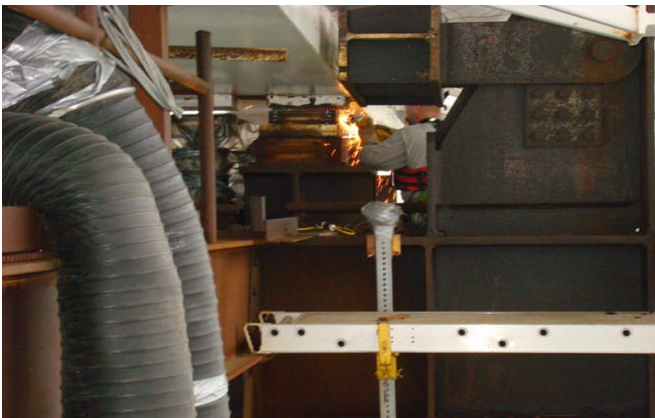
ABF ironworker using a grinder on the Skyway steel tub falsework to remove support shims for full range of vertical thermal movement of the bridges.
